## MIL "ON" DTC - P015A-D A/F Sensor (1GR-FE)

YEAR(S)	MODEL(S)	ADDITIONAL INFORMATION
2012 – 2014	Tacoma

Some 2012 – 2014 model year Tacoma vehicles equipped with 1GR-FE engines may exhibit a MIL "ON" condition for the following Diagnostic Trouble Codes (DTCs):

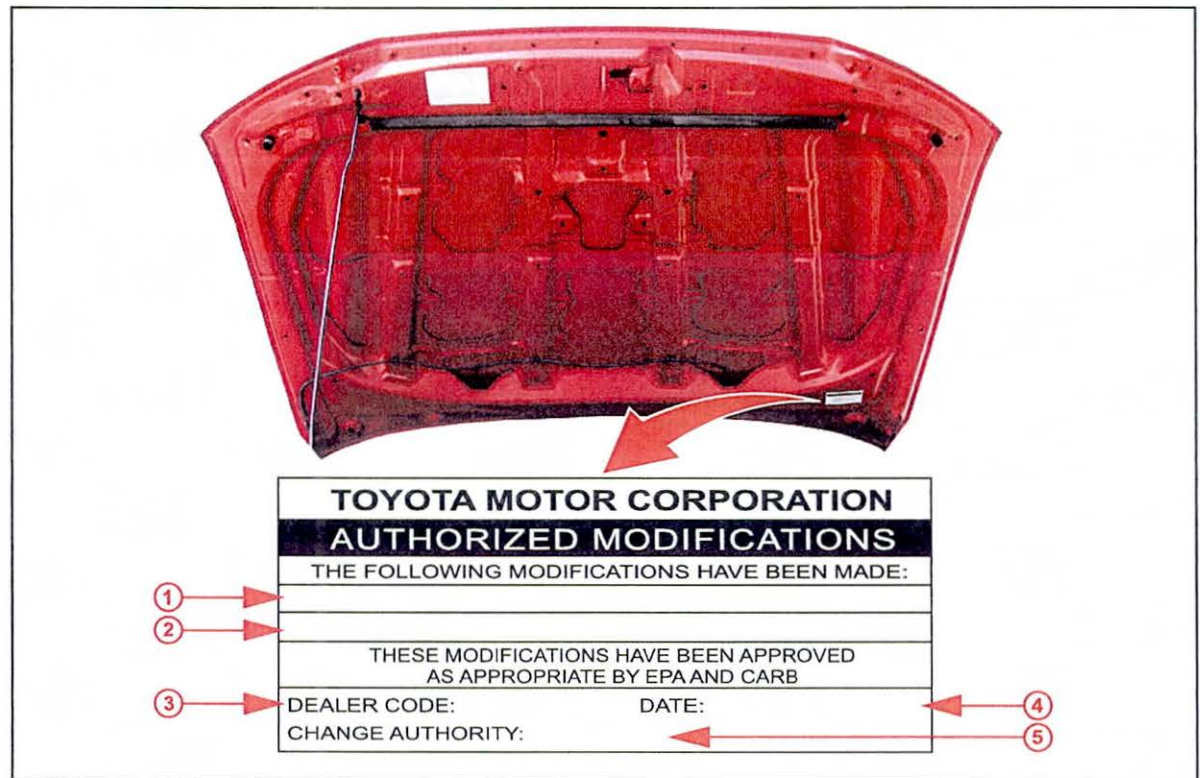
Figure 1. Location of Authorized Modifications Label on 2012 – 2014 Tacoma

1	Replacement ECM (PCM) Part Number (i.e., 89661-04E01)
2	New Calibration ID(s) (i.e., 30455100)
3	Dealer Code

4	Date Completed
5	This SB Number

- YES** — Continue to step 2.
  - NO** — This bulletin does NOT apply. Continue diagnosis using the applicable Repair Manual.
- Check for the Authorized Modifications Label affixed to the vehicle in the location shown in Figure 1. Confirm if the ECM (PCM) calibration has been updated. If the calibration ID listed is NOT the latest ECM (PCM) calibration — go to step 3. If the calibration ID is the latest, go to step 5.

4. Install the Authorized Modifications Label.
  - A. Using a permanent marker, enter the following information on the label:
    - ECM part number [Refer to the **Parts Information** section for the **NEW PART NUMBER**]
    - Calibration ID(s) [Refer to the **Calibration Information** section for the **NEW CALIBRATION ID**]
    - Dealer Code
    - Repair Date
    - Change Authority [**This bulletin number**]
  - B. Affix the Authorized Modifications Label to the vehicle at the location shown in Figure 1.  
The Authorized Modifications Label is available through the MDC, P/N 00451-00001-LBL.
5. Test drive to confirm the repair.
